Failure Investigation for an AR Open-Graded Friction Course in Sweden

Swedish Road Administration

February 2010

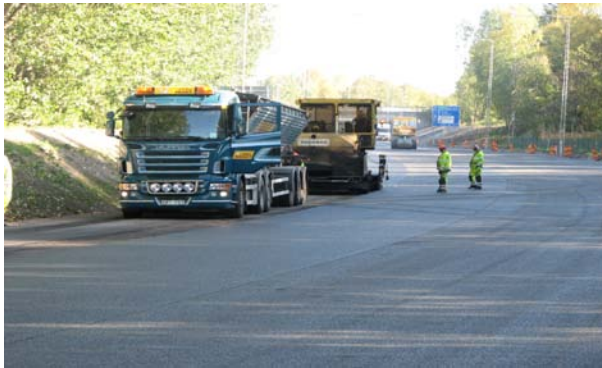
Figure 2.1 - Paving of asphalt-rubber OGFC in Norrköping, Sweden.

SRA provided several pictures during the construction process. Figure 2.1 is an overall view of the mix during paving operations. A close-up photo of the mix after paving and compaction is displayed in Figure 2.2.

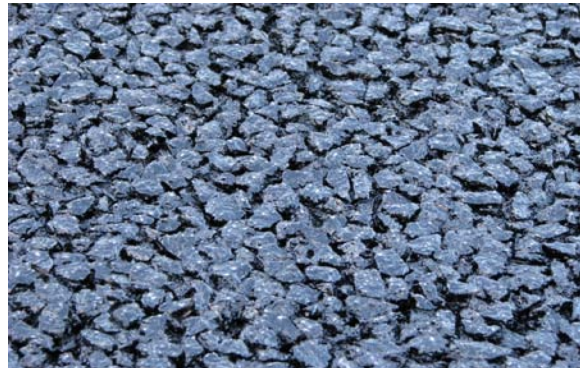
Figure 2.2 – Pavement surface immediately following paving and compaction.

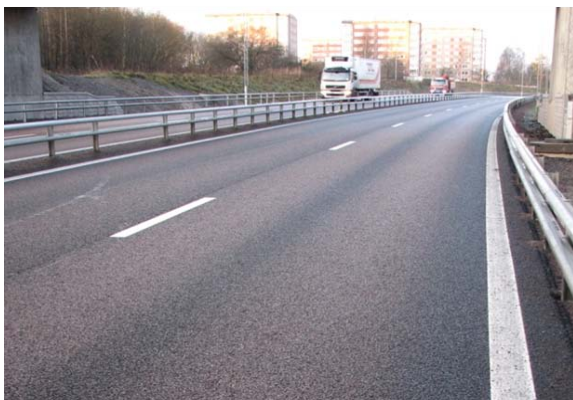
SRA reported that the asphalt-rubber mix placed on the highway began to fail approximately 4-6 weeks following construction. The first signs of failure were in the form of raveling on the pavement surface. After 8-9 weeks of service, SRA removed and replaced the pavement to avoid monetary claims for damage to windshields and cars. Figure 3.1 displays the pavement surface prior to replacement. Loss of binder from the aggregate in the wheel paths is evident in the figure. Figure 3.2 shows an example of loose stones on the pavement surface due to raveling.

Figure 3.1 – Pavement surface prior to replacement.

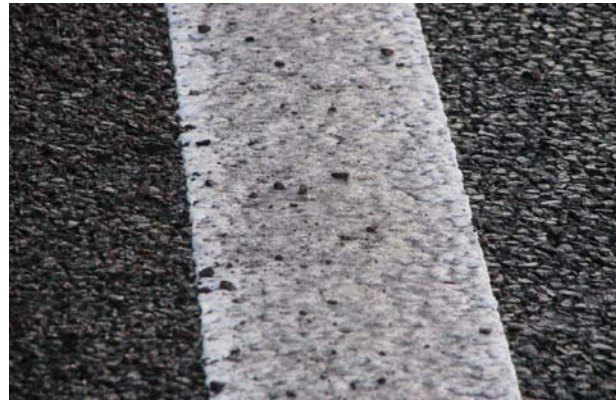
Figure 3.2 – Loose aggregate on the pavement surface due to raveling.

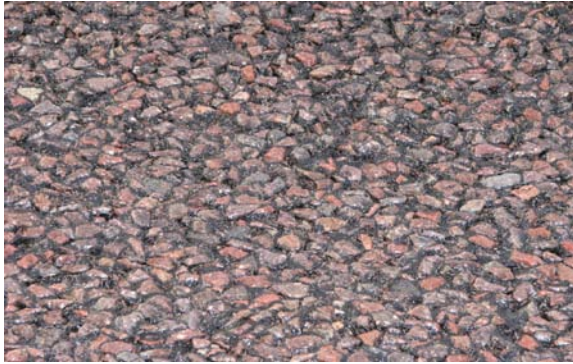
The extent of the binder loss is shown in Figure 3.3. Nearly all the asphalt binder was removed from the surface of the aggregates in the trafficked areas. Raveling is also evident in the areas of pavement that did not receive traffic as shown in Figure 3.4.

Figure 3.3 – Pavement surface in trafficked areas prior to replacement.

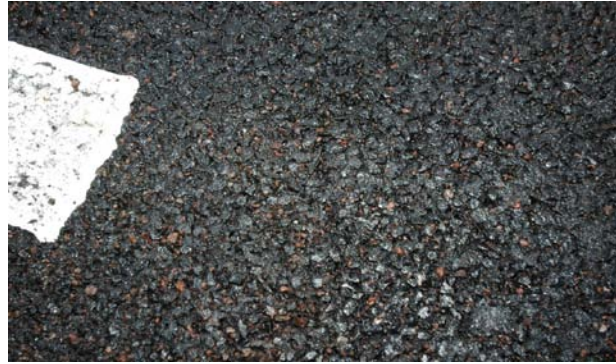
Figure 3.4 – Pavement surface in un-trafficked areas prior to replacement.

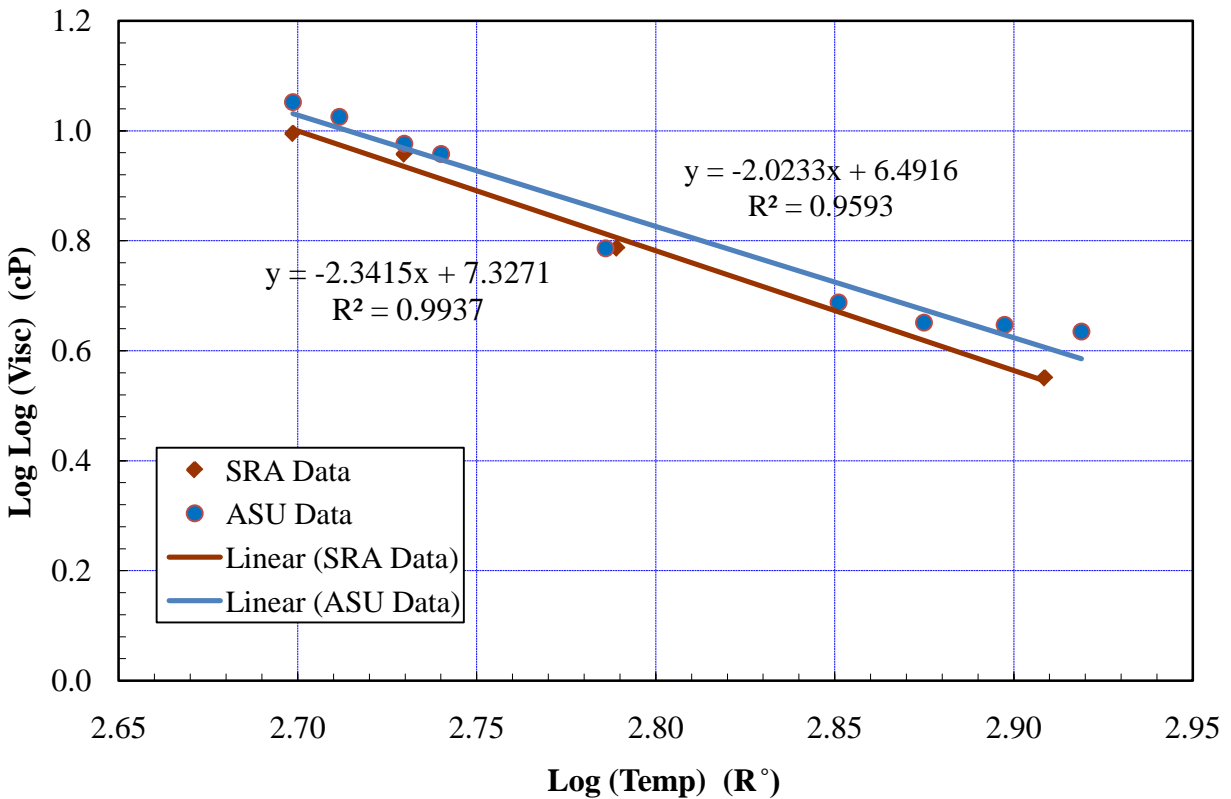
Figure 4.1 presents a comparison of the temperature-viscosity relationships constructed using SRA and ASU binder test data. According to the comparison, the slopes of the lines are very similar. The shift in ASU test data from SRA are typical test results for an aged asphalt binder. In this case, the binder aged from the time of production until it reached the laboratory at ASU. From the data, it can be concluded that testing at ASU confirmed initial binder test data provided by SRA.

Figure 4.1 – Comparison of viscosity-temperature relationships for asphalt-rubber binder.

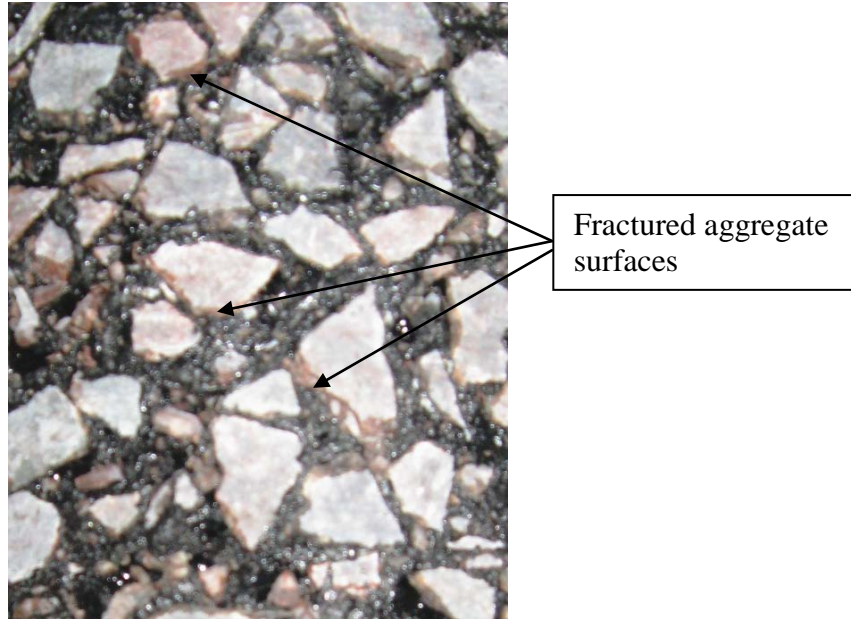
Initial samples compacted at approximately 17% air voids exhibited extensive aggregate fracturing, especially at the edges of the aggregate. Figure 4.2 shows an example of the aggregate fracturing of numerous aggregates in the sample.

Figure 4.2 – Fractured aggregate surfaces after compaction.

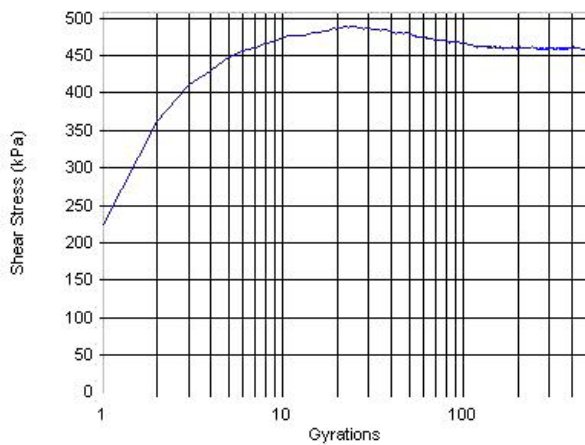
Gyratory shear plots were also analyzed and for the 17% air void sample, the maximum shear strength was obtained prior to reaching the desired level of compaction. In other words, the shear stress reached a peak and began to decrease as a result of aggregate fracturing. This is graphically shown in Figure 4.3. Figure 4.4 and 4.5 present gyratory shear plots for typical 19% and 21% air void samples, respectively. In all three figures, the shear stress peaked around 500-510 kPa but reduced to around 460 kPa for the 17% air void sample. It is important to note that actual air voids of the in place pavement were between 15-17% and that if aggregate fracturing occurred at 17% air voids, it is certain that more fracturing occurred at the 15% air void level. Gyratory shear plots for all samples can be found in Appendix B.

Figure 4.3 - Gyratory shear plot (17% Va)

Gyratory shear plots confirmed the hypothesis by showing a reduction of shear stress during compaction for the 17% air void samples. Typically, this trend indicates aggregate fracturing during the compaction process. Once the samples were completed, fracturing was noticed on the surfaces of the aggregates. It is important to note that even though the 19% and 21% samples did not exhibit shear stress decline, fractured aggregates were evident after compaction. These fractured aggregates left surfaces uncoated with binder after compaction which could have been easily raveled from the surface with the application of traffic loading.

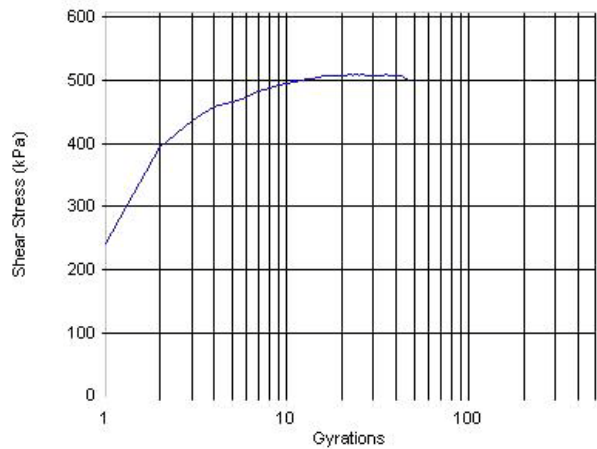
Figure 4.4 - Gyratory shear plot (19% Va)

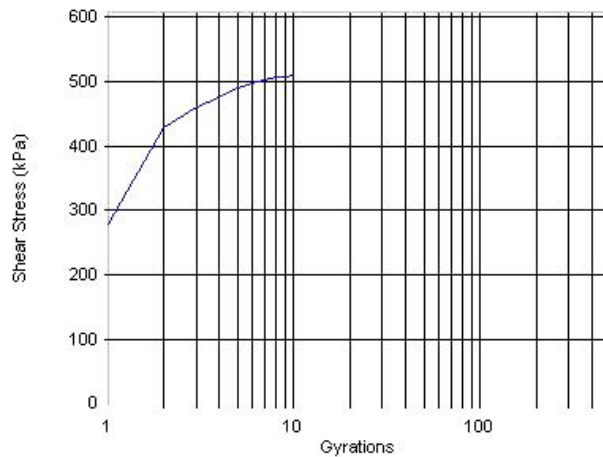
Figure 4.5 - Gyratory shear plot (21% Va)

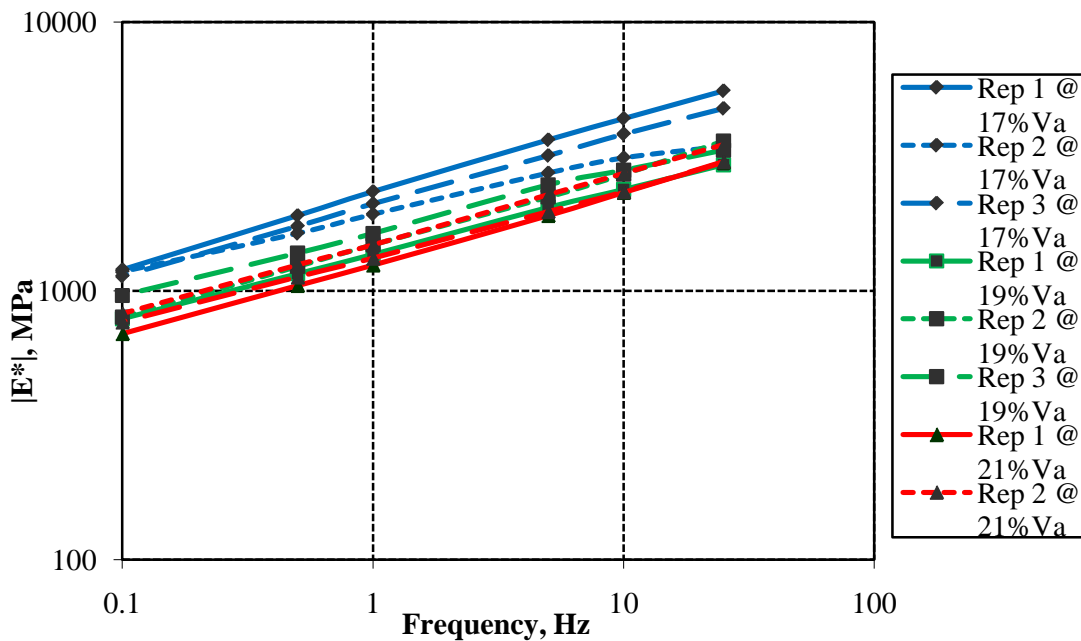
Three samples from each air void group were subjected to an unconfined dynamic modulus test at 70°F to evaluate the mix stiffness properties. Applied load frequencies were 25, 10, 5, 1, 0.5 and 0.1 Hz. Figure 4.3 graphically displays a comparison of dynamic modulus values while tabular data can be found in Table 4.6.

Figure 4.6 – Dynamic modulus versus loading frequency for Swedish OGFC.

According to Figure 4.3, the samples with 17% air voids had the highest dynamic modulus values across all loading frequencies. Samples with 19% and 21% air voids appear to have similar dynamic modulus values. Table 4.3 presents the mean, standard deviation and coefficient of variation (CV) values for three replicates of a mix at each frequency. CV values indicate some variability in the data especially for higher loading frequencies. The highest variability was in the 17% air void samples at 25, 10 and 5 Hz.

Analysis of variance was performed on the dynamic modulus data using a 95% confidence level. Analysis of these data indicates that there are no statistical differences between dynamic modulus values for the 19% and 21% air voids samples across all loading frequencies. However, when comparing 17% to 19% and 17% to 21% air void samples, the dynamic modulus values are statistically different. This is the case for all frequencies except 25 Hz. The large variance of data at 25 Hz may have resulted in accepting the null hypothesis that data sets were indifferent. Table 5.1 presents the F-values used for statistical comparisons.

Dynamic modulus testing was performed for comparison between the samples. The test indicated that dynamic modulus values of the 17% air voids samples were greater and statistically significant ($\alpha=0.05$) in comparison to the 19% or 21% samples. There were no statistical differences between the dynamic modulus values of the 19% and 21% air void samples. These results indicate that the dynamic modulus test may not have been the best test selection to assess aggregate damage. It may be the case that the crushed aggregate in the 17% air void sample modified the gradation which resulted in higher dynamic modulus values.

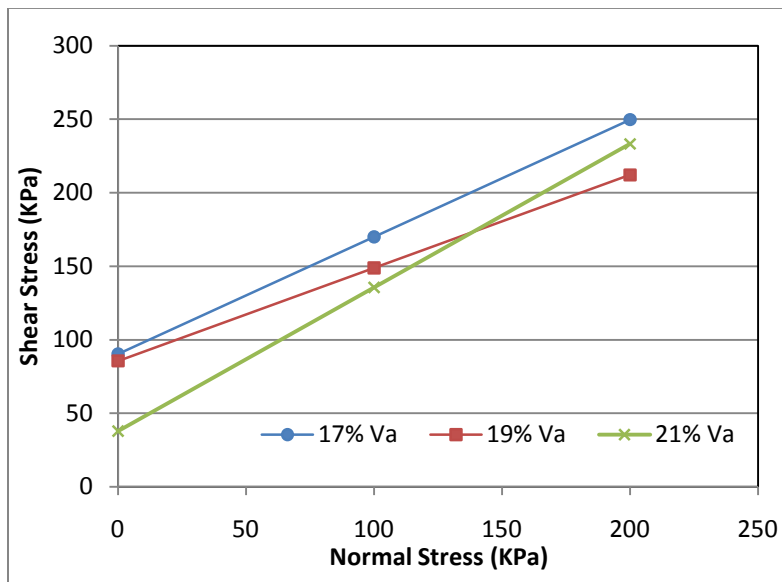
Mohr-Coulomb failure envelopes for the three mixes were plotted in Figure 4.7 using Equation 2 and the values from Table 4.5. Again it is evident that the c-parameter of the 21% air void mix is much lower than the 17% and 19% mixes.

Figure 4.7 – Mohr-Coulomb failure envelope comparison.

Comparisons of the ϕ parameters indicate that the 17% air void samples had a slightly higher angle of internal friction than the 19% samples. One reason for this may have included a change in gradation due to excess aggregate crushing during compaction. The additional fractured aggregate may have lead to increased shear resistance with an applied load. Due to the limitations of the 21% air void data, these samples were not considered when making this comparison.

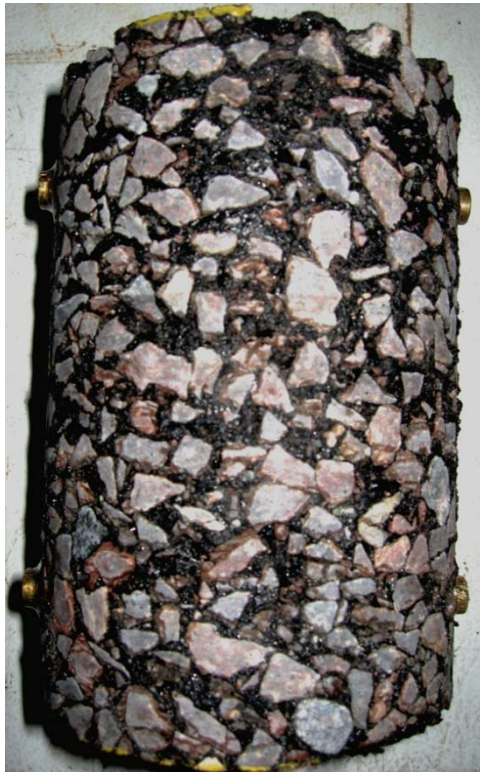
Figure B.1 – 17% Air void sample.

Photographs of the compacted specimens and gyratory shear plots can be found in Appendix B. Observations after compaction support the initial finding that aggregate fracturing occurred during laboratory compaction.

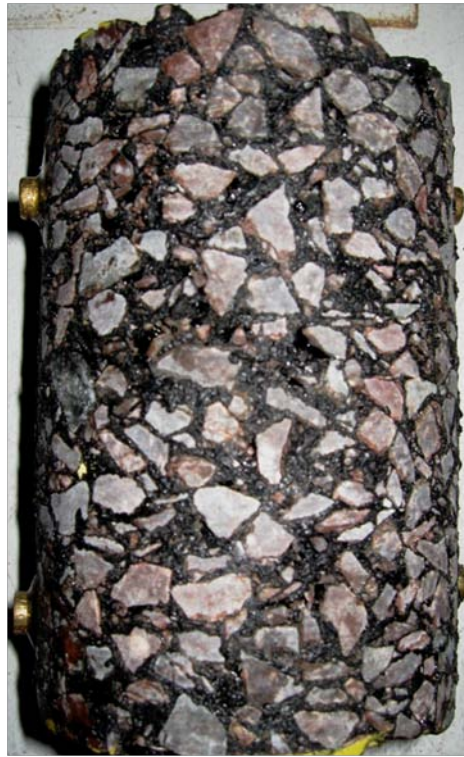
Figure B.2 – 19% Air void sample.

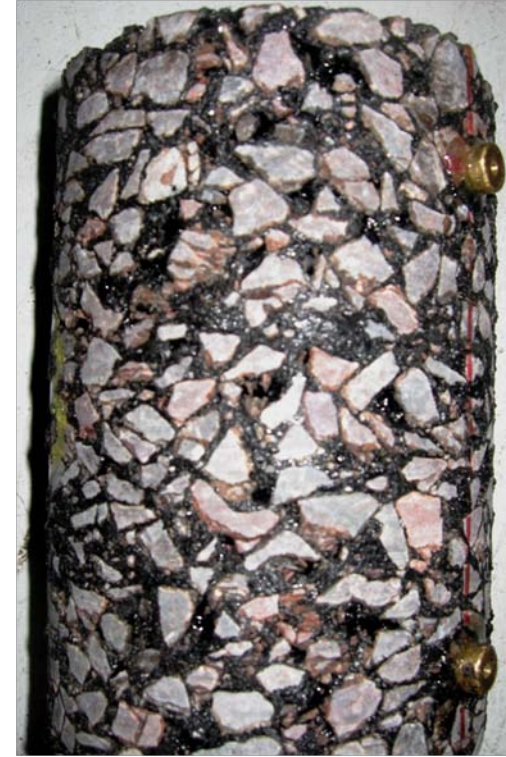
Figure B.3 – 21% Air void sample

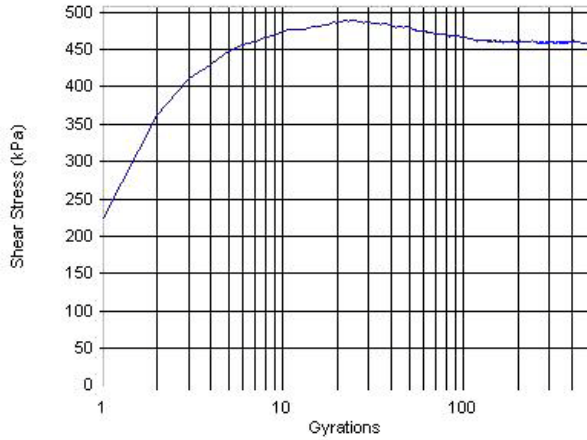
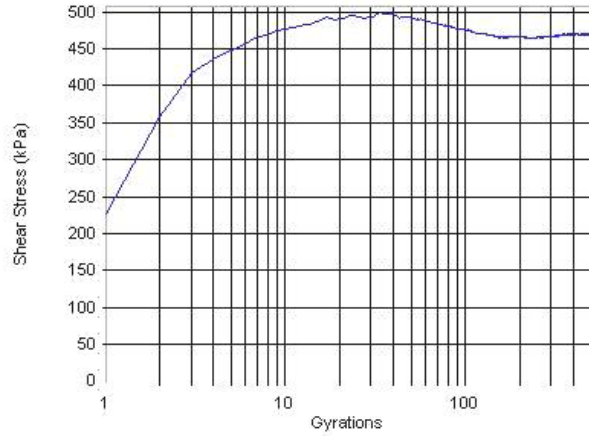
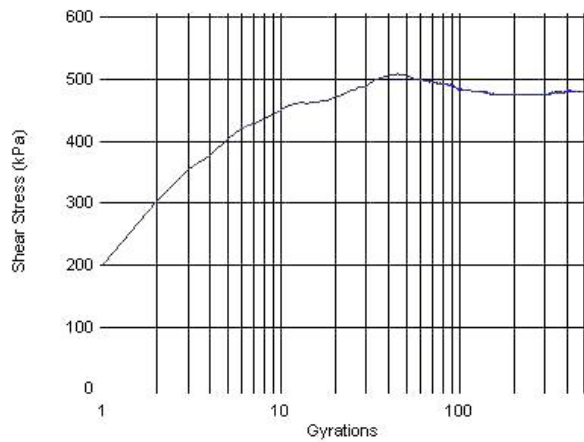
Figure B.4- Gyrotory shear plot, 17% Va – Rep 1.

Figure B.5- Gyrotory shear plot, 17% Va – Rep 2.

Figure B.6- Gyrotory shear plot, 17% Va – Rep 3.

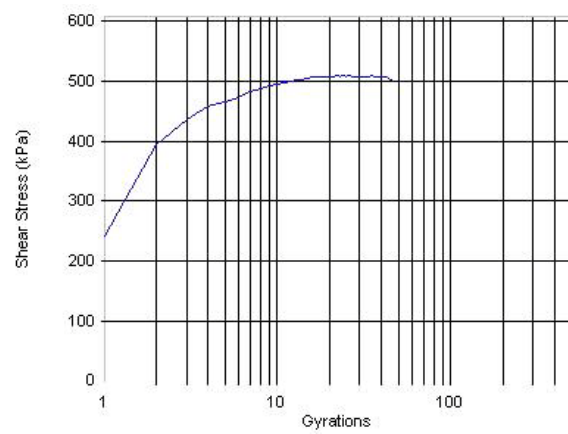
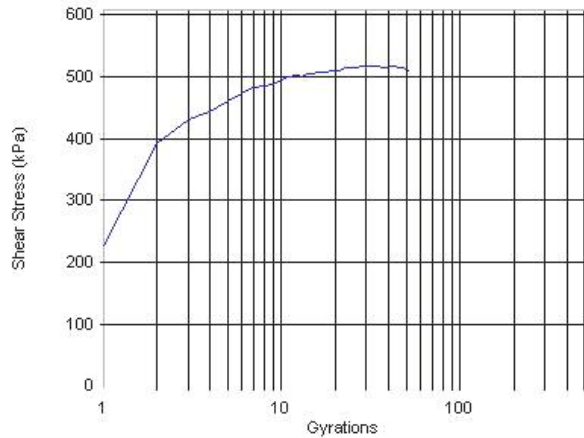
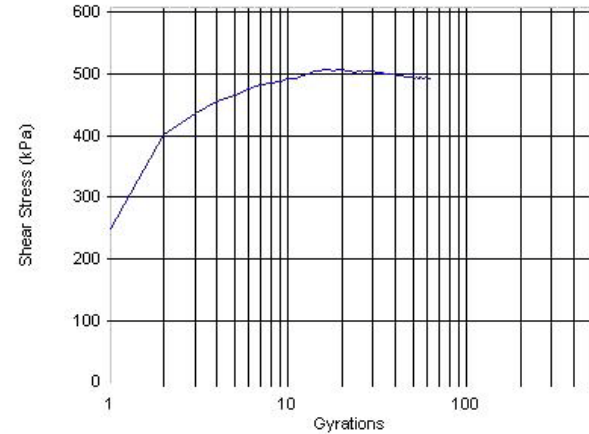
Figure B.7- Gyrotory shear plot, 19% Va – Rep 1.

Figure B.8- Gyrotory shear plot, 19% Va – Rep 2.

Figure B.9- Gyrotory shear plot, 19% Va – Rep 3.

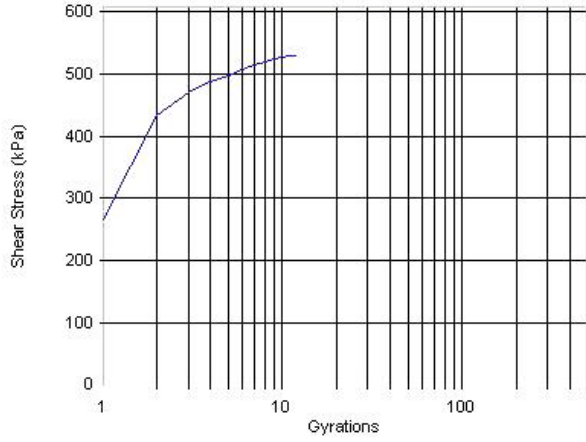
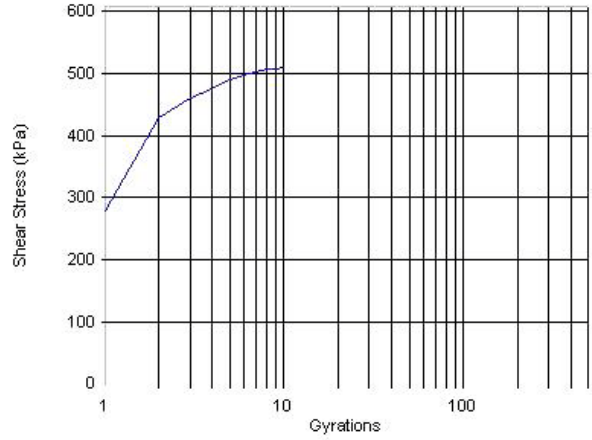
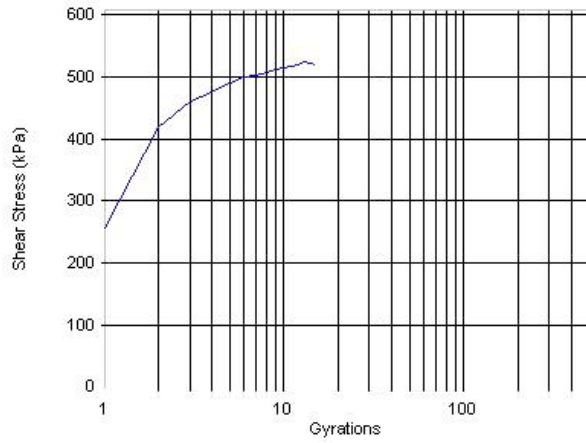
**Figure B.10- Gyratory shear plot, 21% Va –
Rep 1.**

**Figure B.11- Gyratory shear plot, 21% Va –
Rep 2.**

**Figure B.12- Gyratory shear plot, 21% Va –
Rep 3.**

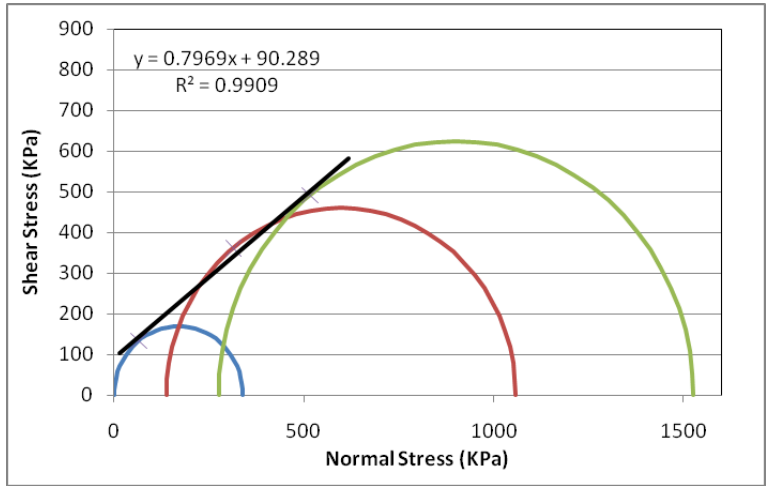
σ_3 (Kpa)	Sample #	Maximum σ_1 (KPa)	Strain @ Failure	Time @ Failure (Sec)
0	1	340	2.1	210
138	1	920	6.8	500
276	1	1250	3.8	280

Figure C1 – Mohr-Coulomb failure envelope plot for 17% air voids.

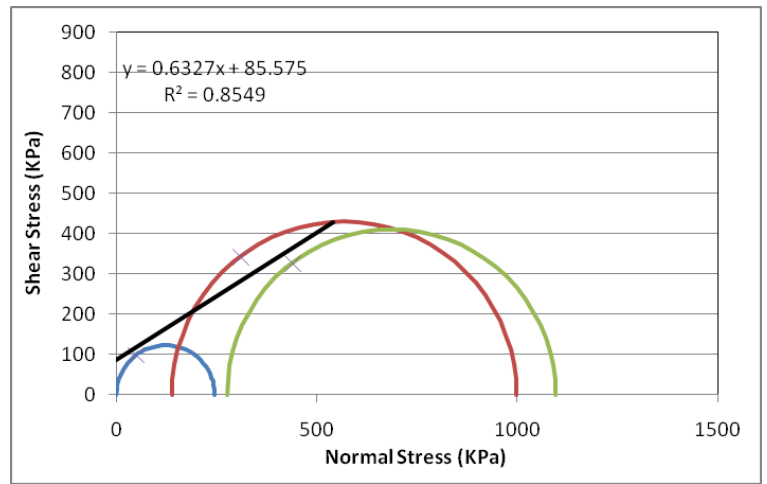
σ_3 (KPa)	Sample #	Maximum σ_1 (KPa)	Strain @ Failure	Time @ Failure (Sec)
0	1	245	2.6	190
138	1	860	11.9	870
276	1	820	9.2	680

Figure C1 – Mohr-Coulomb failure envelope plot for 19% air voids.

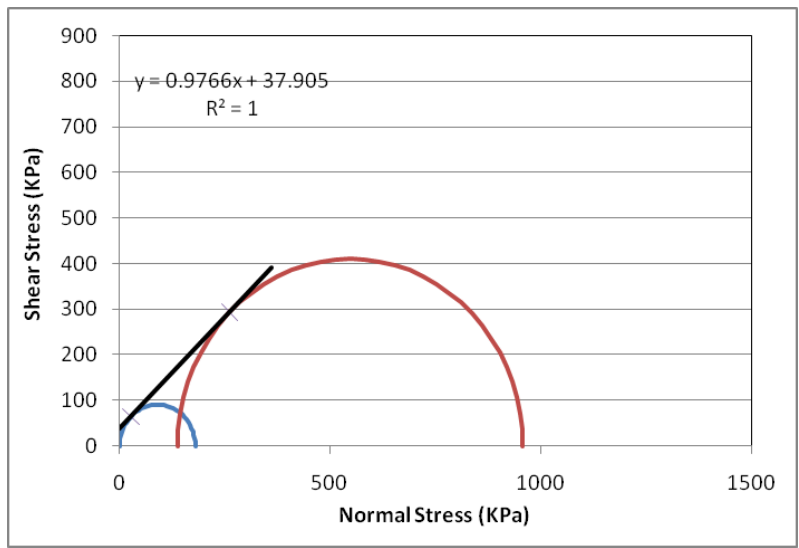
C =	37.90
ϕ =	44.32

Note: No test data available at $\sigma_3 = 276$ kPa.

Figure C1 – Mohr-Coulomb failure envelope plot for 21% air voids.
